Experimental and numerical analyses of a deep foundation containing a single defective pile

Bored pile, Defective piles, Loading test, Numerical analysis, instrumentation

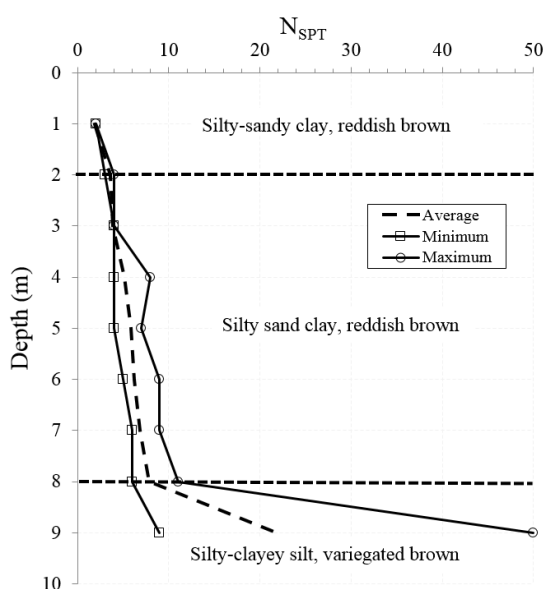
Figure 1 Simplified typical geological profile of the experimental field and summary of the standard penetration test (SPT) (modified after Rodriguez, 2013).

Figure 1 shows a simplified geological profile of the experimental site obtained from an in situ testing program of standard penetration test (SPT) performed by Rodriguez (2013). In Figure 1, it is observed that the SPT blow count shows little variability, perhaps as a function of the effect of suction variations. The range of results increases below 8 m, perhaps as a function of the proximity of the rock strata which presents variable depth within the site. Scallet (2011) and Schulze (2013) performed static load tests on single piles, which have the same geometric characteristics and instrumentation as the pile tested herein. This also serves as a basis to the present analyses.

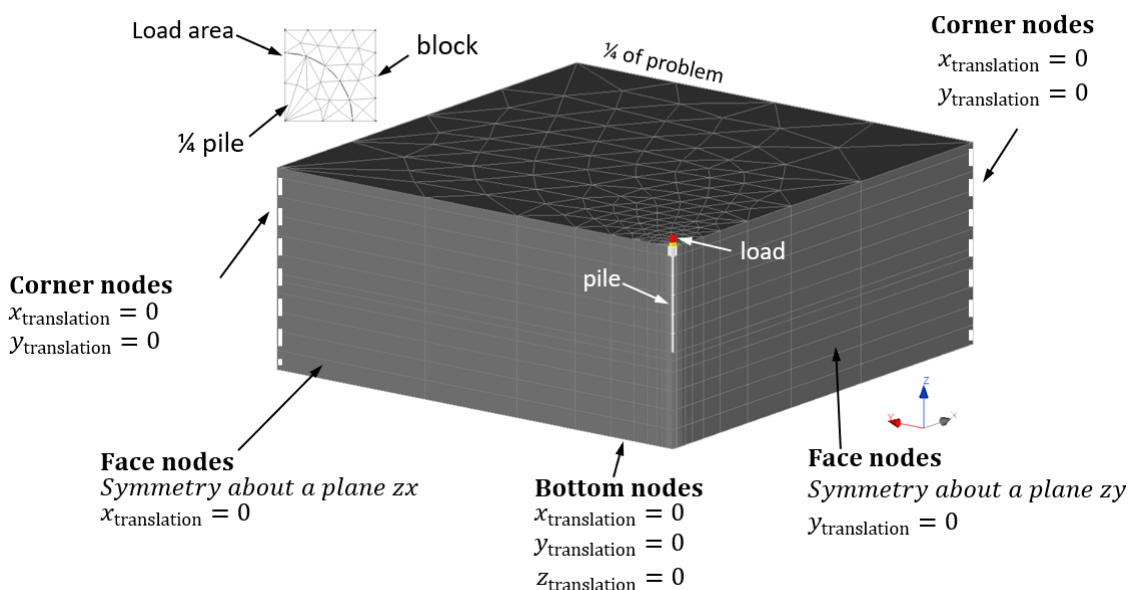
Figure 2 Boundary conditions of one quarter a symmetric 3D model.

The dimensions of the model and the respective number of nodes and elements were checked. The evaluated geometries were: 30 m x 30 m, 40 m x 40 m and 50 m x 50 m. The boundary conditions imposed to the problem were verified at each simulation of the validation process, in which the boundary conditions of the 50 m x 50 m mesh exhibited maximum deformations less than one tenth of a millimeter, which is considered insignificant for the type of problem under analysis (Figure 2).

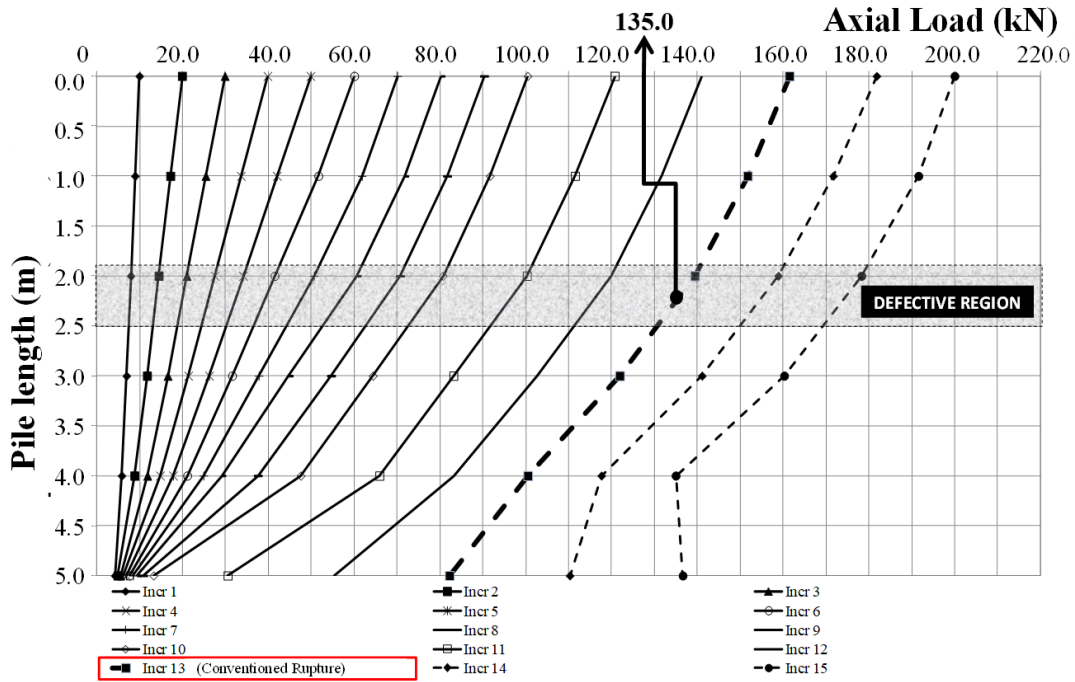
Figure 4 Numerical prediction of the compressive load along depth on the axis of the simulated isolated pile (Freitas Neto, 2013).

Figure 3 also shows a defined geotechnical ultimate load capacity equivalent to 25 mm settlement obtained from the load vs. settlement curve in the numerical FEM analysis, performed by Freitas Neto (2013), which in this case was equal to approximately 163 kN (Figure 3). Because the loads were reduced along the depth, variation of the axial load along the pile axis (Figure 4) was also determined from the numerical analyses.

The load in the section referring to the position where the defect would be inserted (varying between 1.9 m and 2.5 m of depth in the field) varied between 130 kN and 140 kN when the load on top of the pile measured 163 kN. The average structural compressive load corresponding to this cross-section, where the defect would be experimentally installed, was 135 kN (Figure 4). Thus, applying a safety factor of 2 (according to Brazilian standard NBR 6122:2010), a value of 67.5 kN was obtained, i.e. equivalent to the load mobilized at the section during the admissible, working, and geotechnical conditions. Since the idea was to have the isolated pile failing structurally at the defective zone just before it reached this admissible load, the defective section had therefore to be designed to withstand a maximum structural load of 67.5 kN.

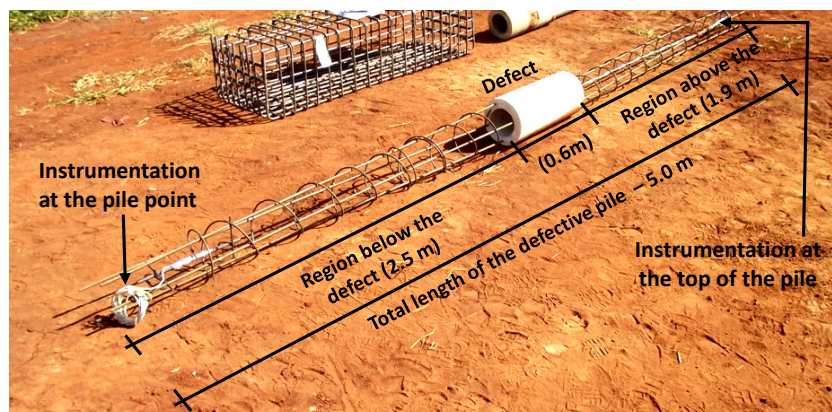
Figure 6 Longitudinal design of the defective pile (total length, size and positioning of the defective zone and placement of instrumentation).

the defect was installed. The defect was positioned in the upper medium segment of the pile, i.e. between depths of – 1.9 m to –2.5 m (Figure 5). This position was defined by considering that the closer the defect to the surface, the higher its influence on the foundation behavior. Figure 6 shows the longitudinal composition of the defective pile. In this case, the installation sequence followed the procedure given below:
