# Comparison of seismic performances of reinforced concrete frames strengthened by different techniques

Mehmet Baran <sup>a\*</sup>

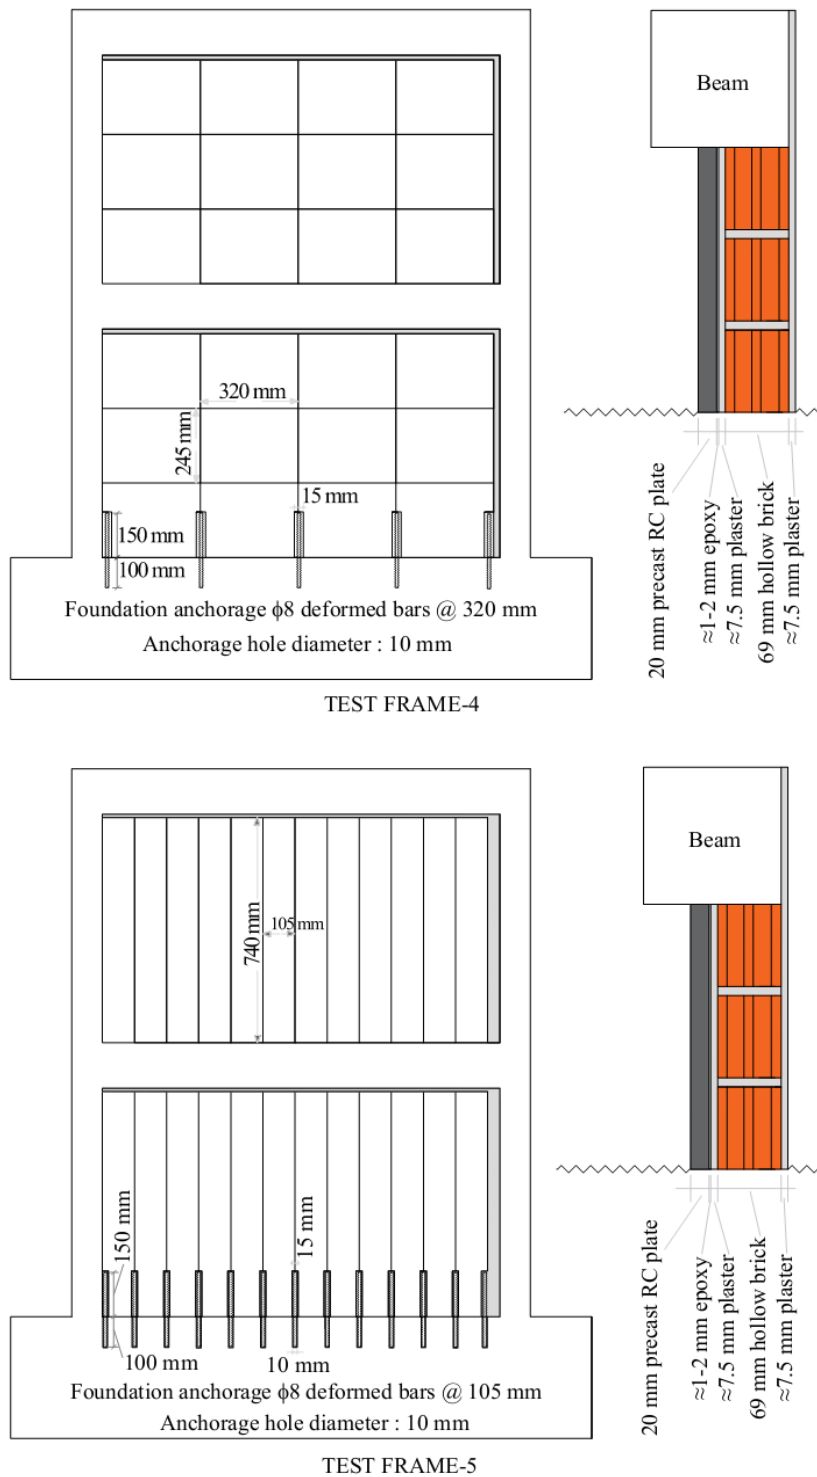
Test Frames-4 and Test Frames-5 were strengthened by bonding of precast RC plates having dimensions of 320 mm × 245 mm and 105 mm × 740 mm, respectively. Thickness of both plate types were 20 mm, and all plates were bonded on to the plastered infills at both stories via two-component epoxy, Sikadur-31 (Sika, 2001) of 2 mm thickness. RC plates were precast in the laboratory using steel molds. Wire mesh of f3/50 type, easily can be found in the market, were used as reinforcement of a single layer in the production of plates. Rectangular plates used in Test Frame-4 and strip plates used in Test Frame-5 had compressive strengths of 33.4 MPa and 32.0 MPa, respectively. RC plates were intendedly designed to be cast with high strength concrete in order that they can supply the required strength to test frames cast with low strength concrete. In order to transfer the shear force to the foundation, dowels of 8 mm diameter deformed bars, 250 mm in length, were embedded 100 mm into rigid foundation. Five dowels were used (spacing was 320 mm) for Test Frame-4 whereas thirteen dowels were used (spacing was 105 mm) for Test Frame-5. Diameter of the dowel holes were 10 mm for both test frames. For both frames, since precast RC plates were bonded on the plaster by the use of a strong two-component adhesive and it was thought that hollow brick infills together with the plates would behave as a rigid infill due to strong adhesion of plates to plastered infill, it was concluded that dowels to be used only at the foundation level with the aim of minimizing the workmanship. The use of dowels in between all individual plates were seen to be redundant. The spacing in between RC plates and anchorage bars were filled with the two-component epoxy, Sikadur-31 which have a compressive strength of 20 MPa. Strengthening process was finished with the filling of these spacings such that no extra plastering of the infill was needed. Details of the strengthening techniques are illustrated in Figure 3.

Figure 3 Strengthening with precast RC plates (rectangular plate – strip plate).

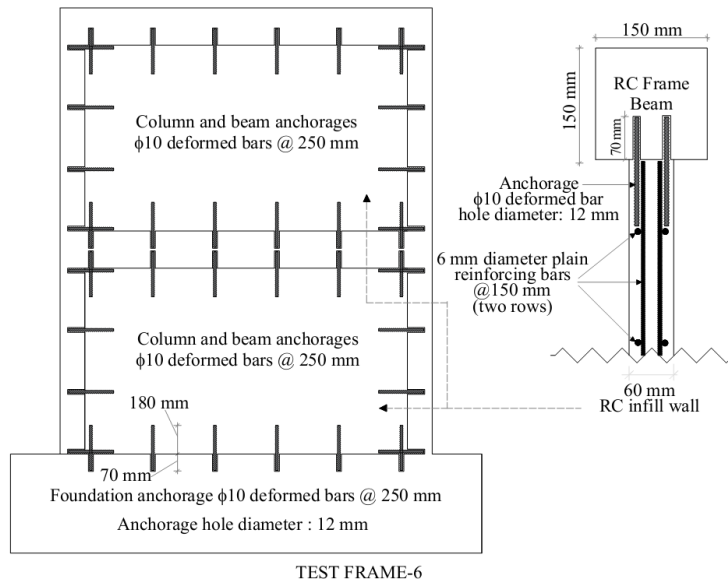
Test Frame-6 was strengthened with 60 mm thick cast-in-place RC infill wall added at both stories. RC infills were cast symmetrically in the plane of loading. Details of this technique (RC infill wall) is illustrated in Figure 4. Compressive strength of concrete used as RC Infill was 23.1 MPa. Reinforcement of RC infills were prepared in the laboratory as f6/150 mm plain bars for both directions (in wire mesh layout). In order to maintain the force transfer between the frame members and the RC infill, dowels of 10 mm diameter deformed bars, 250 mm in length, were embedded 70 mm into columns and beams at a spacing of 250 mm. Diameter of the dowel holes were 12 mm. They were cleaned firstly with a metal brush and then with compressed air. After cleaning, they were then filled with epoxy (Spit Epcon System, 2005) and anchorage bars were placed. Reinforcement of the RC infill was mechanically fixed to anchorage bars.

Figure 4 Strengthening with RC infill walls.

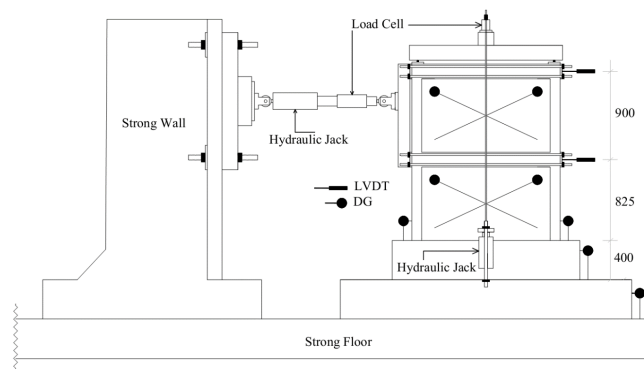
Test configuration of the specimens, loading system and instrumentation is illustrated in Figure 5. Test Frames were tested under reversed cyclic lateral loads simulating earthquake effects. To solve the lateral load distribution problem, the lateral load was applied on a spreader beam at one-third of its span in a triangular manner simulating earthquake effect. Lateral load supplied by the hydraulic jack in 2:1 ratio to both stories to ensure that the lateral load at the second floor level always remains twice as the lateral load at the first floor level. Total lateral load applied was measured with a load cell. Capacity of the hydraulic jack was 600 kN in compression whereas 420 kN in tension. A steel guide frame was constructed around the test specimen in order to prevent out-of-plane deformations. The columns in the long direction were connected to each other by steel box sections. In the short direction the columns were connected by steel L sections. The connection of the steel frame with the test specimen was conducted at second storey level by means of four rollers attached to the box sections and gently touching the test frame. Rollers permitted horizontal as well as vertical in plane movement of the test frames. Up to maximum load capacity, loading controlled cycles were applied where displacement-controlled loadings were applied for further cycles in non-linear region. The lateral load level was the same for the forward and backward half cycles and was increased nearly 10 kN at every full cycle up to displacement-controlled cycles. The same loading history were intended to be applied on the specimens, however backward and forward half cycle loadings were controlled by second storey level displacements when the response of the test frames became non-linear. Test frames attained different capacities, showed different failure mechanisms and behaviour due to the differences in details of the strengthening techniques. For this reason, different displacement-controlled loading cycles were applied on the specimens. Tests were considered to be complete when a definite second-storey level displacement was reached. Second-storey level displacement vs. lateral load were monitored during tests. An axial load corresponding to nearly 15% of column’s axial load capacity was applied on each column using prestressed tendons. Storey-level displacements were measured by Linear Variable Displacement Transducers (LVDT) whereas rigid body rotations and shear deformations of the infill walls were measured by mechanical Dial Gauges (DG). At each cycle, newly formed cracks were marked on the specimens and failure mechanisms were observed.

Figure 5 Test setup and instrumentation (dimensions in mm).

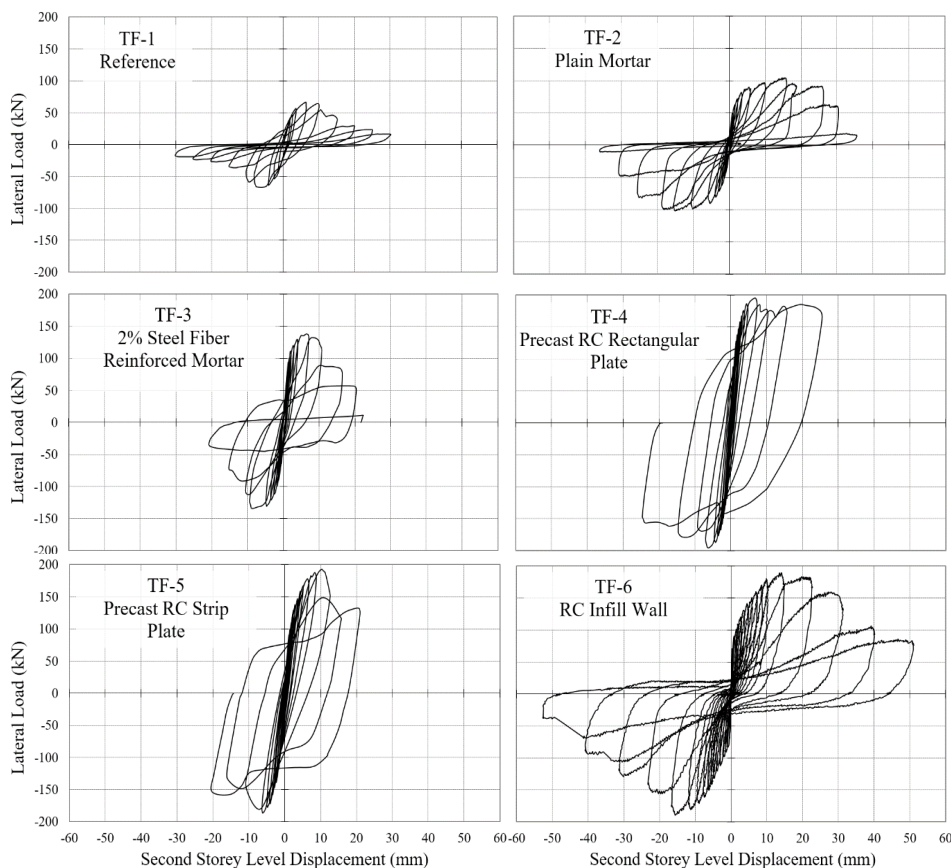
Lateral load – Second storey level displacement graphs of specimens are illustrated in Figure 6. As can be seen from these graphs, all techniques increased lateral strength, stiffness, and energy dissipation capacities of strengthened test frames.

Figure 6 Lateral load–second storey level displacement graphs of all test frames.

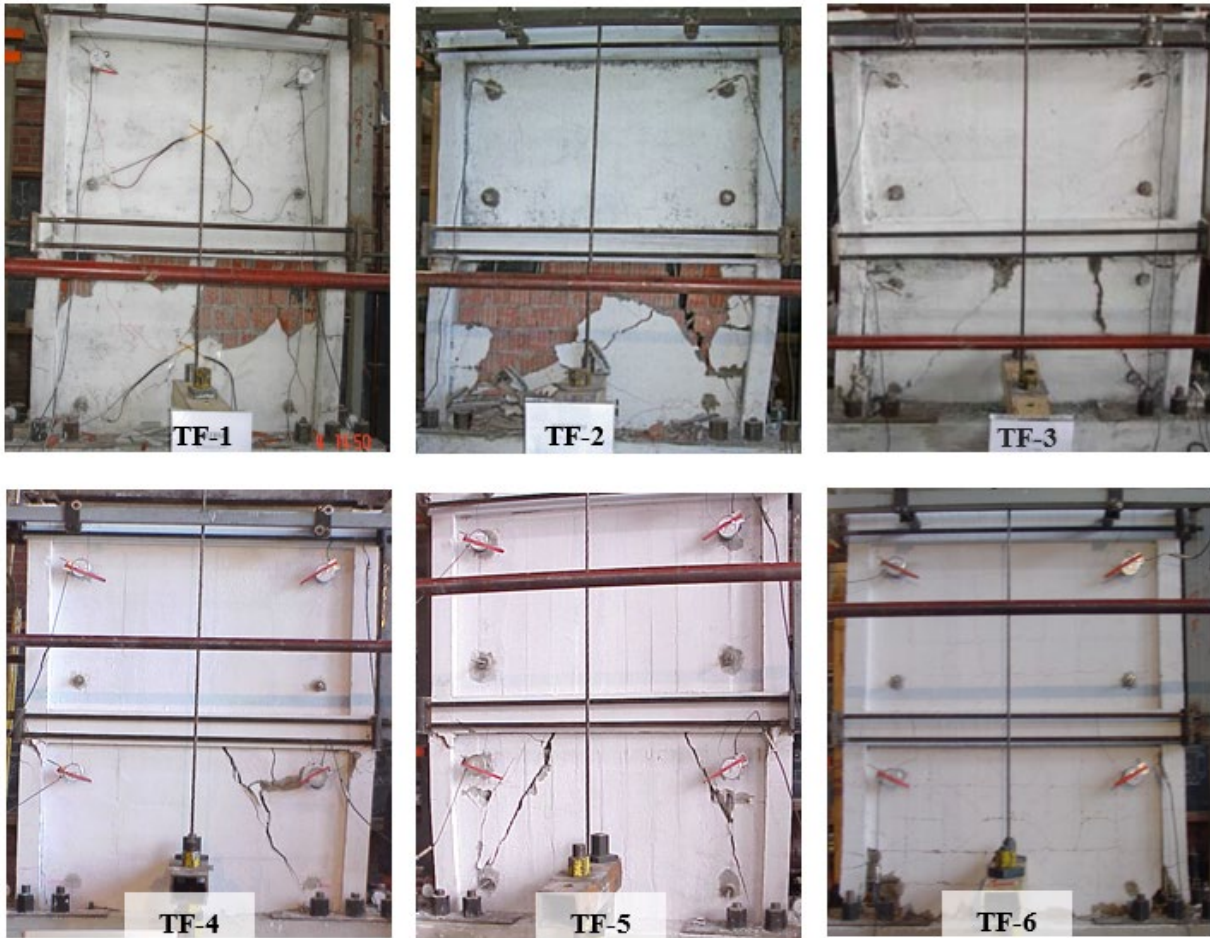
Figure 7 Photographs of all frames after tests.

In the cycles prior to maximum loading, X-shaped shear cracks occurred in the diagonal compression zones of the first storey hollow brick infill wall of the reference specimen. Test Frame-1 attained a lateral load of 66.6 kN at 0.43% first storey drift ratio. Test was ended up when the specimen lost its load carrying capacity with the crushing of the upper corners of the hollow brick infill wall under diagonal compression. Specimen failed with reaching to high storey drift ratios after exceeding maximum load. Relatively larger shear cracks occurred at column-beam connections of the first-storey due to poor confinement of these regions. Photograph of Test Frame-1 after the test is illustrated in Figure 7.

Although plain mortar layer applied on the interior side of the infill increased lateral strength and stiffness to a limited extend, Test Frame-2 could be able to carry the applied lateral loads to nearly 3% first storey drift ratio values with critical cracks occurring on the plain mortar layer without any separation from the plastered infill wall. Test Frame-2 reached a lateral load level of 104.5 kN at 1.24% first storey drift ratio. Separation in between the strengthened infill and the foundation was observed at nearly 1% first storey drift ratio. Shear cracks occurred at the plain mortar layer and at poorly confined column-beam connections. Despite the anchorage bars added at both storey levels with the aim of having a monolithic behaviour of strengthened infill together with the RC frame, an effective shear force transfer between these two could not be formed due to inadequate adherence between the plastered infill wall and the newly added mortar layer. Hollow bricks fell down at nearly 4% first storey drift ratio and the test was terminated. Photograph of Test Frame-2 after the test is illustrated in Figure 7.

The first crack at the first storey column-beam connection was followed up with the flexural cracks occurred on the columns. With increasing lateral loads, cracks were formed on the plaster of the exterior side. A crack extending from the bottom corner to the middle of the first storey beam occurred on the plain mortar layer at 0.2% first storey drift ratio. This crack initiated an increase in shear deformations, extra shear crack occurrence at column-beam connections and column base cracks. Test Frame-3 reached a lateral load level of 140.4 kN at 0.56% first storey drift ratio. At this lateral load level, separation between the first storey infill and the first storey beam occurred and flexural cracks were observed on this beam. After the maximum load cycle, severe damage was observed on the first storey frame members, cover concrete of columns fell off where longitudinal reinforcement of columns buckled. Column ends of the low strength RC frame suffered damage since shear forces were carried from the infill wall to the RC frame by means of diagonal compression struts. Photograph of the Test Frame-3 after the test is illustrated in Figure 7.

Following the column base cracks, separations were observed in plate-RC frame foundation level together with the column bending cracks, and the bending cracks in the middle region of the columns expanded and moved towards the front faces of the columns. Although no cracks were observed on the plates up to the thirteenth forward cycle loading level (~175 kN), a diagonal crack occurred on one of the lowest row plates of the first storey infill. Test Frame-4 reached a lateral load level of 195.7 kN at 0.53% first storey drift ratio. Beginning with the sixteenth forward cycle, displacement-controlled loading cycles started to be carried out, separation in between the first storey beam – plates and a diagonal crack just below the first storey beam were observed. In the proceeding few cycles, separations were observed at the second storey beam – plate and second storey column – plate connections where crushing occurred on one of the lowest row plates of the first storey infill. The test was terminated with an acceleration in the crushing at the base of one of the columns in the last cycle. The anchorage bars embedded only at the foundation level in between RC plates came out to be insufficient to transfer the shear forces between the strengthened infill and RC frame. If complete use of anchorage bars in between RC plates at four sides of both stories were provided, there would be a significant improvement in behaviour such that an intended cantilever beam behaviour (monolithic RC frame-infill wall behaviour) would be exhibited by this frame and failure was dominated by flexure instead of shear. Photograph of the Test Frame-4 after the test is illustrated in Figure 7.

With the start of the test, separations in between the first storey column – plate connections, cracks on the columns and plaster cracks on the exterior side of the frame were observed in the few first cycles. In the following cycles, new flexural cracks on the columns and separations in between the frame foundation – plate connections were observed. In the tenth forward and backward loading cycle, shear cracks were formed at the first-floor column - beam connections. In the next cycle, separations in between the second storey column - plate connections and diagonal cracks on the first storey plates were observed. From this moment on, Test Frame-5 cannot carry more lateral load and displacement-controlled loading cycles were carried. In the next loading cycle, crushing occurred at the column – beam connections and plaster pieces broke off and fell down. In the later phases of the test, diagonal cracks on the first storey plates expanded and cracks at first storey column – beam connections turned into shear failure. Test Frame-5 reached a lateral load level of 192.7 kN at 0.66% first storey drift ratio. As in the case of Test Frame-4, the anchorage bars embedded only at the foundation level in between RC plates came out to be insufficient to transfer the shear forces between the strengthened infill and RC frame. Complete use of anchorage bars in between RC plates at four sides of both stories would improve the behaviour significantly and Test frame-5 would exhibit an intended cantilever beam behaviour (monolithic RC frame-infill wall behaviour), as in the case of Test frame-4. Photograph of Test Frame-5 after the test is illustrated in Figure 7.

The first hairline cracks on Test Frame-6 were observed at the locations where mesh reinforcement of the first storey RC infill wall was placed. In the ongoing first loading cycles, cracks on the columns, separations at the first storey RC infill – foundation connection level and diagonal cracks on the first storey RC infill wall were observed. In the tenth loading cycle, new cracks were formed on both RC infill walls and the separation at the first storey RC infill – foundation connection level became more apparently. Test Frame-6 reached a lateral load level of 189.7 kN at 0.79% first storey drift ratio. From this stage on, displacement-controlled loading cycles started to be carried out, column longitudinal reinforcements buckled, crushing at the column bases and at the concrete of first storey RC infill – foundation connection level occurred. Since this frame exhibited cantilever beam behaviour (monolithic RC frame-infill wall behaviour), anchorage bars embedded to all frame members proved to be sufficient for transferring the shear forces between the RC infill and frame members. Photograph of Test Frame-6 after the test is illustrated in Figure 7.

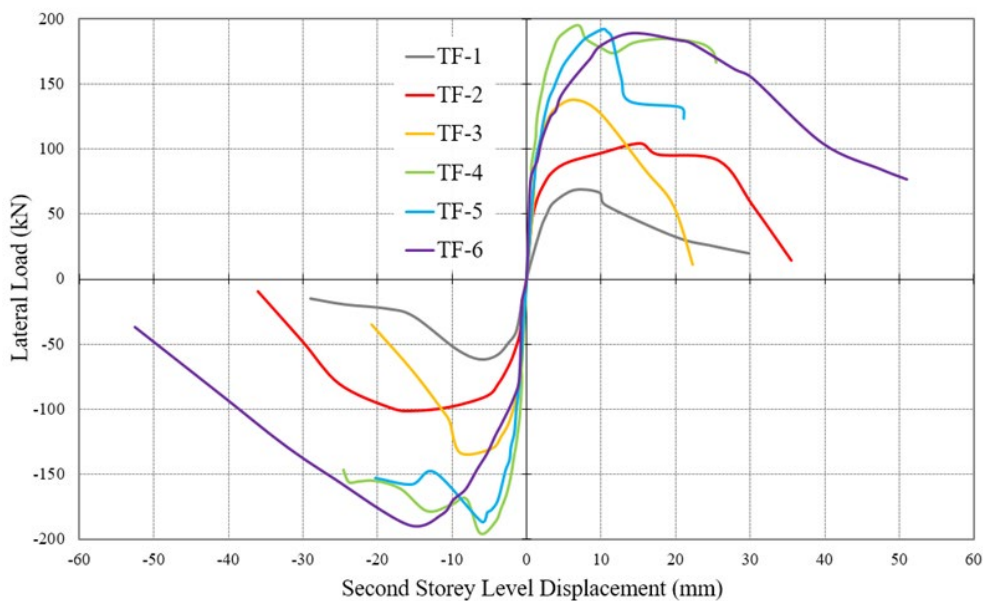
Response envelope curves illustrated in Figure 8, which were constructed by connecting the peak points of each forward and backward cycles of the load-displacement curves, will be used for evaluating strength and stiffness characteristics of all frames. As can be seen from this figure, strength and stiffness of strengthened specimens came out to be significantly higher than those of reference. Each strengthening technique were proved to have different level of effectiveness on RC frames. The lowest lateral load carrying capacity was observed in the case of Test Frame-2 whereas

Figure 8 Response envelopes of all frames.

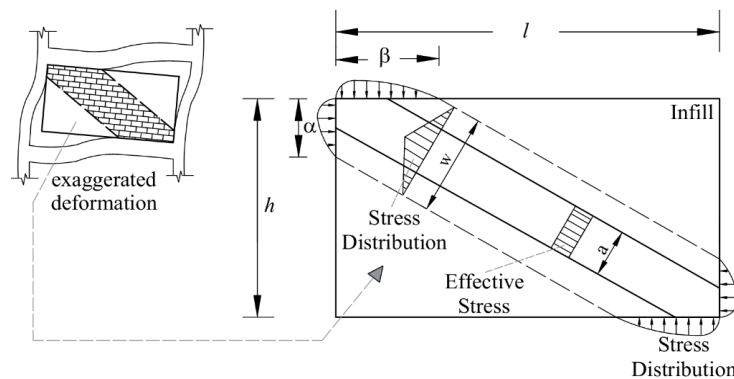
Modelling of plastered hollow brick infills strengthened by mortar (plain or 2% steel fiber reinforced) or precast RC plates (rectangular or strip) is more complex than hollow brick infill modelling, especially when anchorages are taken into account. In this study it is assumed that mortar or plate strengthened infill behaves as a diagonal compression strut as taken into account by Smith and Carter (1969) in their study. Upon lateral load application, separation in between the RC frame and the infill occurs over a partial length of the column and the beam and the contiguity between them retains adjacent to two opposite corners. At this instant, a line drawn from one loaded corner to the other represents the direction of compression. Therefore, it can be assumed that the infill behaves as a diagonal strut adequately representing the load transfer mechanism. Therefore, strengthened test frames can be analyzed with two independent diagonal compression struts which the first is replacing the plastered hollow brick infill and the second replacing the strengthening mortar or plate. The modelling of a diagonal compression strut is shown in Figure 9, where  $l$  and  $h$  are the geometric dimensions of the infill,  $a$  and  $b$  are the interaction distribution factors,  $w$  is the width of the stress distribution along the diagonal compression strut and  $a$  is the effective width of the strut.

Figure 9 Equivalent diagonal compression strut modelling.

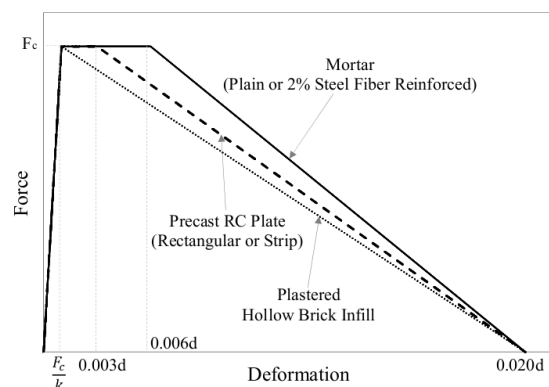
The load-deformation curve of the second compression strut modelling the plain/2% steel fiber reinforced mortar and precast RC rectangular/strip plate as a strengthening layer is illustrated in Figure 10.

Figure 10 Force – deformation curves of compression struts.

where  $f_{c,infll}$  is the compressive strength of the infill,  $a_{infll}$  is the effective width of the strut,  $b_w$  is the thickness of the infill,  $F_{c,infll}$  is the axial load-carrying capacity of the strut,  $E_{infll}$  is the modulus of elasticity of the infill,  $d$  is the diagonal length of the infill and  $k_{infll}$  is the rigidity of the strut. As a result, strength and initial stiffness values of the compression strut modelling the plastered hollow brick infill were taken as 62.5 kN and 69.4 kN/mm in the numerical studies. The load-deformation curve of the first compression strut modelling the plastered hollow brick infill is given Figure 10.

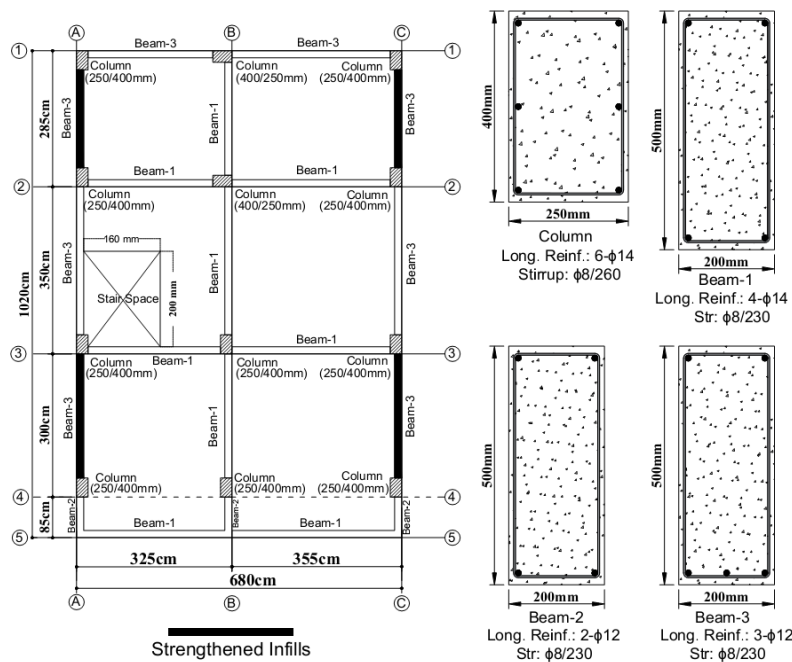
Figure 11 Plan view, column and beam sections and details of strengthening techniques.

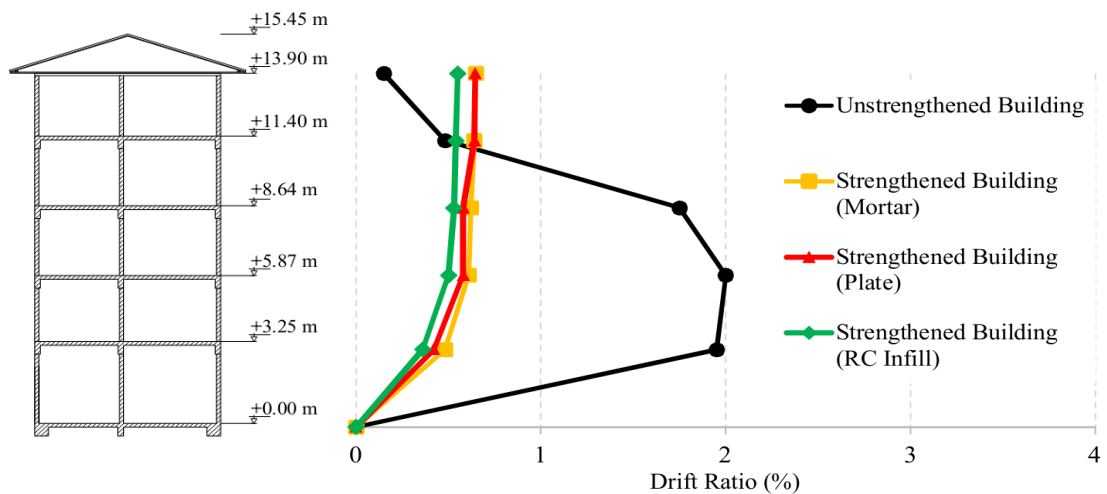
The evaluation of the deficient building indicated that 75% of the first storey columns came out to be at the prevention of failure performance level according to which this building must be strengthened (Turkish Building Earthquake Code 2018). The strengthening techniques described in previous sections were applied to this building. Mortar and plate techniques were applied as diagonal compression struts whereas RC infill was applied using finite element method (shell element). Concrete strength and thickness were determined as 20 MPa and 40 mm for mortar whereas 35 MPa and 30 mm for plate, in order to satisfy the immediate usage performance level for the building in accordance with the Turkish Building Earthquake Code (2018). The interstorey drift ratios obtained from pushover analysis at performance points of the applied earthquake ground motion are shown in Figure 13. The highest interstorey drift ratio occurred at the second-floor level of the unstrengthened deficient building at a value of 2.0%. Upon strengthening application, this ratio reduced to 0.49% for RC infill, 0.57% for plate strengthening and 0.60% for mortar strengthening showing that the strengthening techniques are obviously successful in controlling interstorey drift ratio demands and preventing collapse.

Figure 13 Inter storey drift ratios obtained from pushover analysis.
